Accelerated Testing of Window Joinery made from Eucalypts

Project no: PN98.702

D.K. Scown, L.J. Cookson, K.J. McCarthy & N. Chew

CSIRO FFP

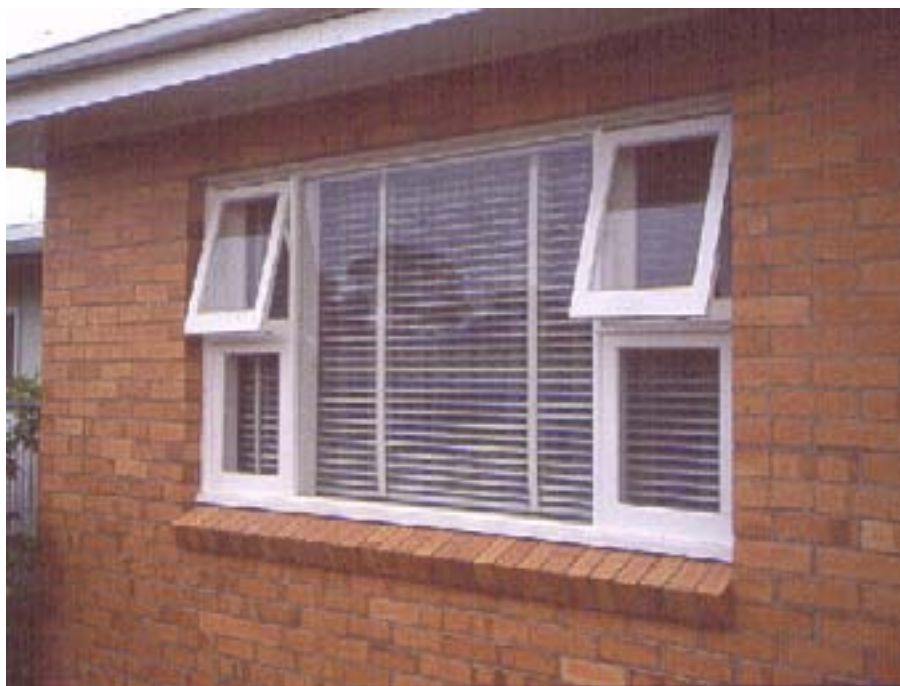
The survey incorporated a group of eucalypt windows in buildings at Bairnsdale. These windows were generally in excellent condition (Figure 1.1). The experience of the joinery supplier responsible for the manufacture of these windows was that sealing the end grain within the joints prior to assembly extended the service life of the joint considerably. He claimed that a poorly made joint would last only 15 years whereas a well made joint can be expected to last more than 40 years. He recommended the use of only oil based paints and a flexible sealant in major joints to protect the end grain of the timber from water ingress. Other tips were to fully paint prime the timber before assembly, including the underside of the timber beading to be used against the glass, and the outer frame and underside that would later be hidden against the brickwork after installation.

Figure 1.1: Eucalypt window 43 years old in Bairnsdale, with internal joints sealed prior to assembly, in excellent condition. For the purposes of the survey, this figure is considered to show one window.

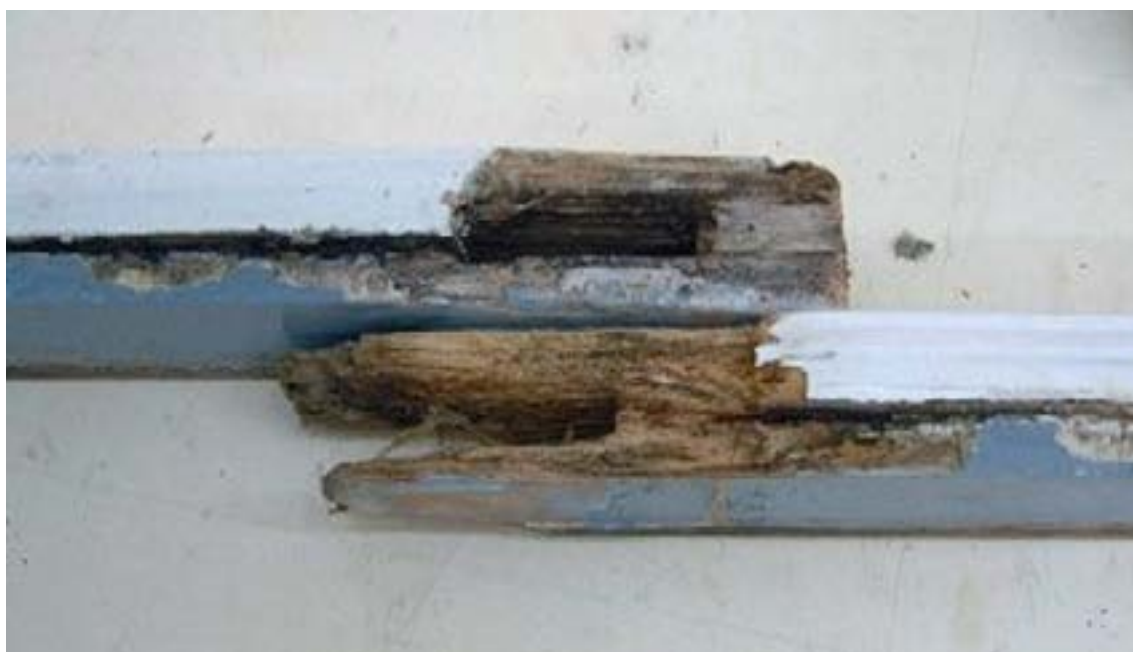
Eucalypt	50	Oakleigh	No	P	White rot present in bottom joint. See Figure 1.3. Window has been replaced.
Eucalypt	60	Clayton	No	P	Brown rot present in bottom joints. Window replaced around three years ago.

**Figure 1.3: White rot in bottom joint of dismantled 50 year-old eucalypt window.**

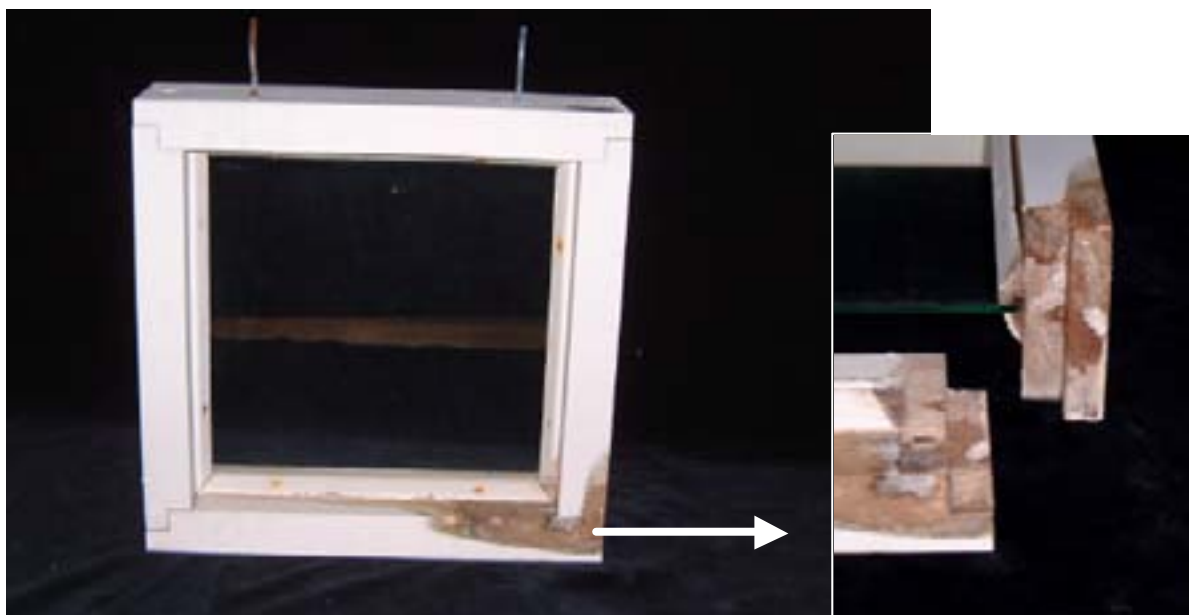
Most painted window frames constructed from untreated *E. regnans*, *E. delegatensis* or *Shorea spp.* failed to decay after three years exposure. Severe decay was often denoted by heavy discolouration of the paint. This discolouration also gave an insight into the pattern of attack, as the decay appeared to originate at the ends of the particular component (within the rebate) and moved progressively away from the rebate, along the grain. This phenomenon is clearly illustrated in Figure 4.2. The value of maintaining the paint coating was also demonstrated in the window survey.

Figure 4.2: Discolouration in the paint due to severe decay in the bottom component of a *Shorea* spp. model window frame. The inset illustrates the extent of the decay in the rebate.

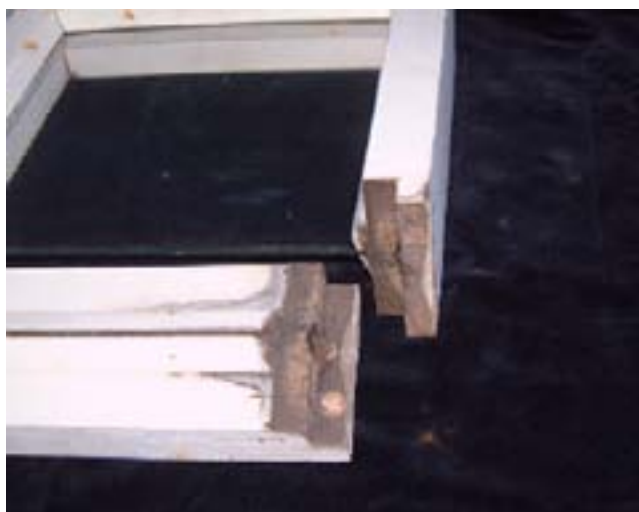
Figure 4.4: Slight decay in the rebate of a boron-treated *E. obliqua* window frame.

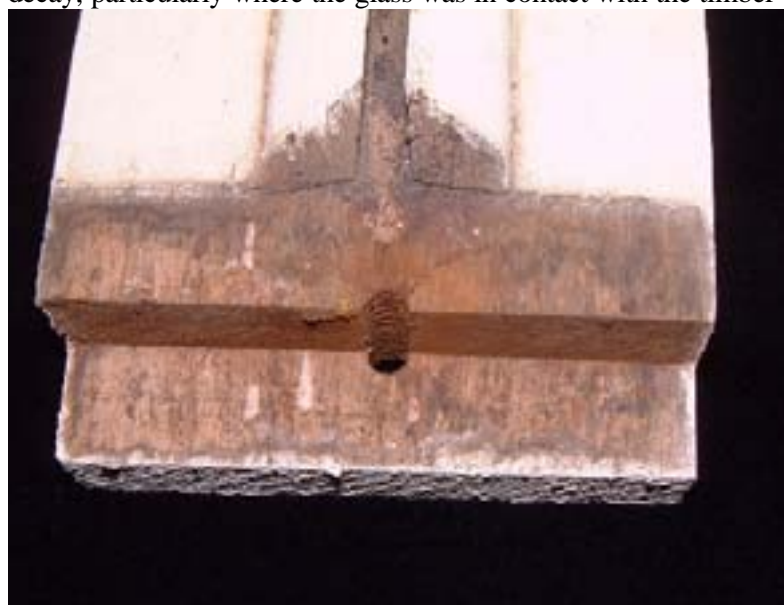
After three years exposure in the AFS and on the roof at Clayton, the LOSP-treated window frames were in good condition with only the one *E. regnans* window frame with slight decay. This *E. regnans* frame had been treated with the current LOSP formulation and had prominent decay, particularly where the glass was in contact with the timber (Figure 4.5).

Figure 4.5: Decay in a window frame made from *E. regnans* treated with the current commercial LOSP formulation.
