# Accelerated Testing of Window Joinery made from Eucalypts

***Publication: Accelerated Testing of Window Joinery made from Eucalypts***

Project no: PN98.702

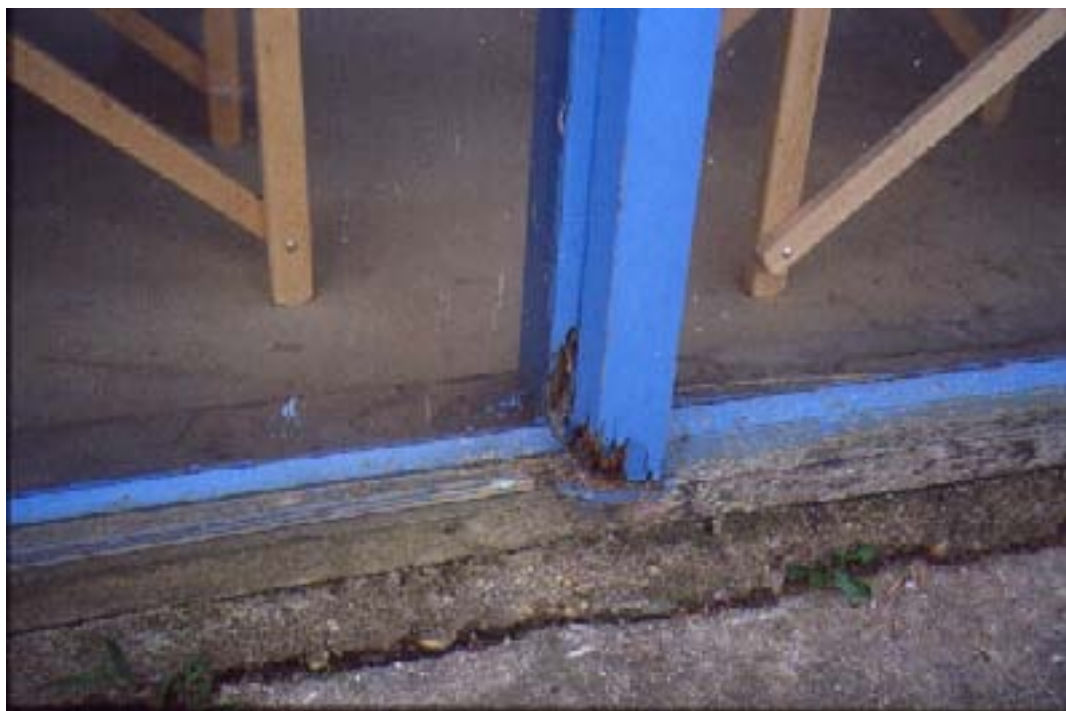
Age	Location	Treatment	Last painted (P) or stained (S)	Eave width (mm)	Orientation of deteriorated windows	Comments
12	Langwarrin	No	1998 (S)	500	North	Surface softening in bottom left joint of window on upper storey. No deterioration 4 other windows upper storey and 6 windows lower storey.
14	Pearcedale	No	1995 (S)	0	?	Windows have gone grey due to physical degradation of surface cells. No decay – 8 windows.
14	East Doncaster	No	1997 (P)	500		No deterioration - 14 windows.
16	Mt. Martha	No	1999 (S)	500	North and north east	Brown rot in bottom left joint and along the sill for 200 mm in one window and brown rot in bottom joints in another. 7 windows no deterioration.
17	Mornington	No	1999 (S)	450	North	Signs of white rot in beading of north facing window. No deterioration – 5 windows.
20	Bairnsdale	No	(P)	0		Window frame plus sliding door with brown rot to 30 mm depth in 3 joints. Needing repair. See Figure 1.2.

**Figure 1.2: Brown rot in a 20 year old untreated western red cedar window.**

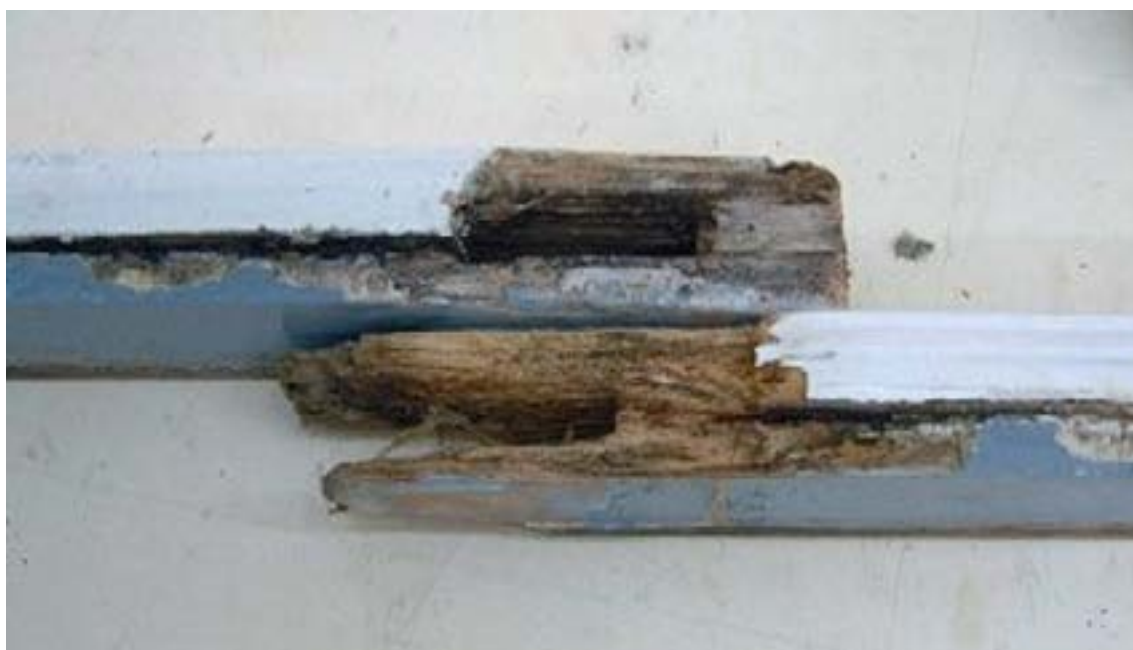
Eucalypt	50	Oakleigh	No	P	White rot present in bottom joint. See Figure 1.3. Window has been replaced.
Eucalypt	60	Clayton	No	P	Brown rot present in bottom joints. Window replaced around three years ago.

**Figure 1.3: White rot in bottom joint of dismantled 50 year-old eucalypt window.**

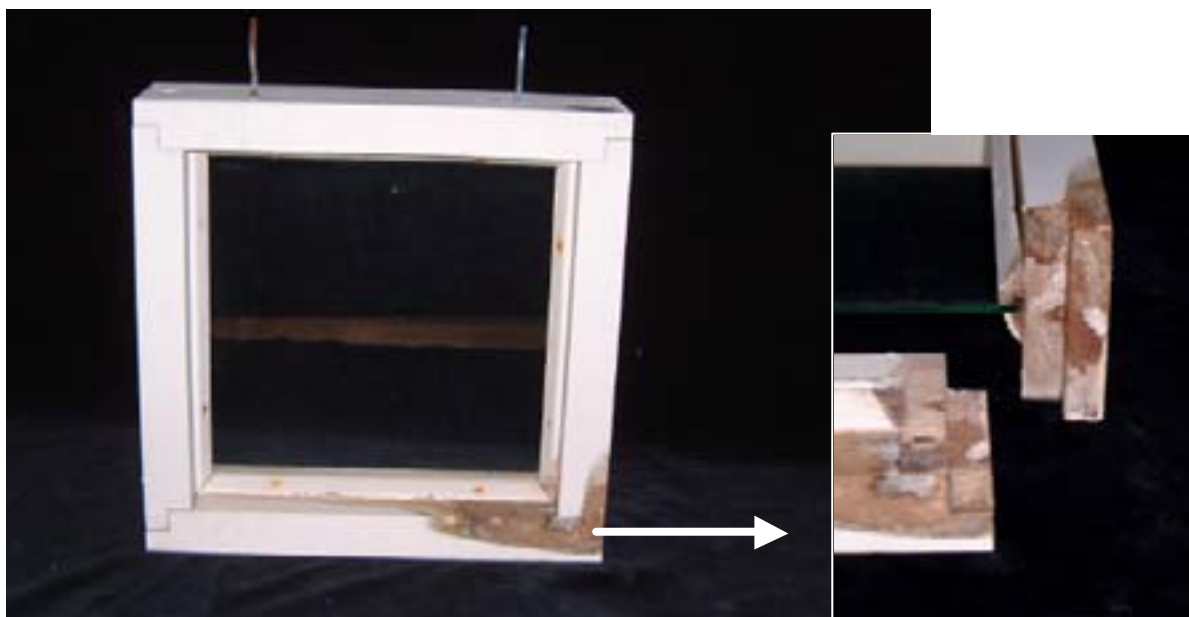
Most painted window frames constructed from untreated *E. regnans*, *E. delegatensis* or *Shorea spp.* failed to decay after three years exposure. Severe decay was often denoted by heavy discolouration of the paint. This discolouration also gave an insight into the pattern of attack, as the decay appeared to originate at the ends of the particular component (within the rebate) and moved progressively away from the rebate, along the grain. This phenomenon is clearly illustrated in Figure 4.2. The value of maintaining the paint coating was also demonstrated in the window survey.

**Figure 4.2:** Discolouration in the paint due to severe decay in the bottom component of a *Shorea* spp. model window frame. The inset illustrates the extent of the decay in the rebate.

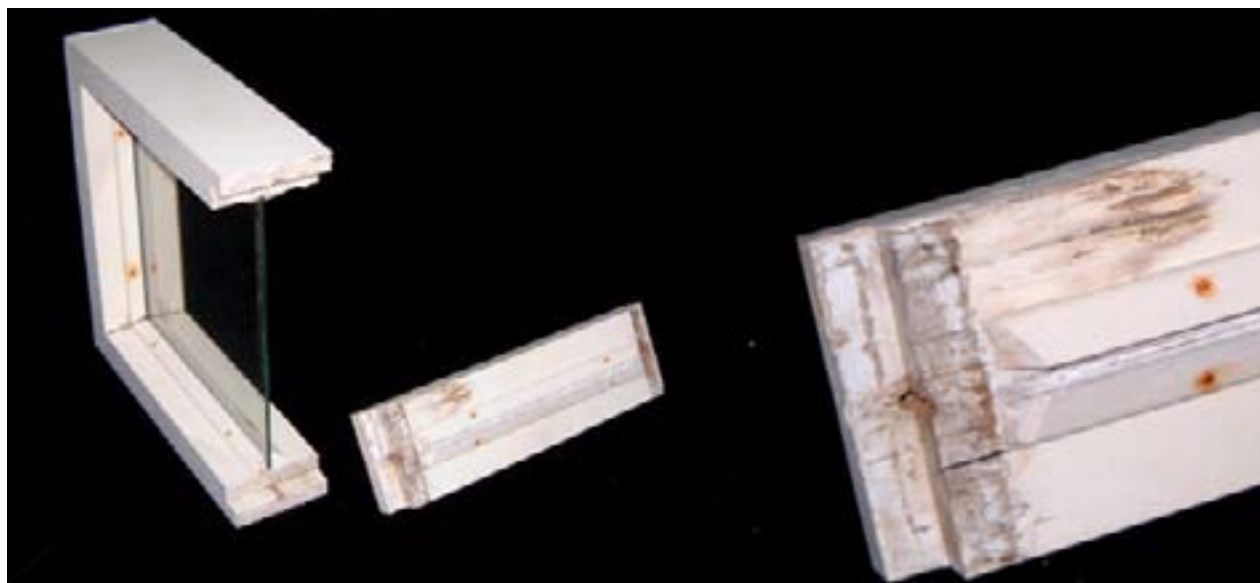
The practice of sealing the end grain before window assembly appeared to promote window durability when 30-40 year-old ash windows were examined in Bairnsdale<sup>13</sup>. The end grain in these windows had been sealed with a lead-based paint which is no longer available. It was thought that additional protection to untreated windows might be obtained by end sealing the internal rebates with primer prior to window assembly. Some evidence in support of this procedure was obtained in the lower rows of frames, where the bottom rebate for end sealed windows had a mean rating of 6.5 compared to 2.7 for similar windows with unsealed rebates. However, a similar trend was not observed in the top row of windows (Table 4.1). While at least some of the aspects of the good performance of joints sealed with lead-based paints can be attributed to the good fungicidal properties of this type of paint, it is likely that the performance of joints with sealed end grain would have been better if the paint used was oil-based, instead of the water-based paint. Figure 4.3 illustrates typical decay in the rebate of an untreated *E. regnans* window that had the end grain sealed prior to assembly.

Figure 4.3: Heavy white rot in the rebate of an *E. regnans* model window frame with sealed end grain.
