# Accelerated Testing of Window Joinery made from Eucalypts

***Publication: Accelerated Testing of Window Joinery made from Eucalypts***

Project no: PN98.702

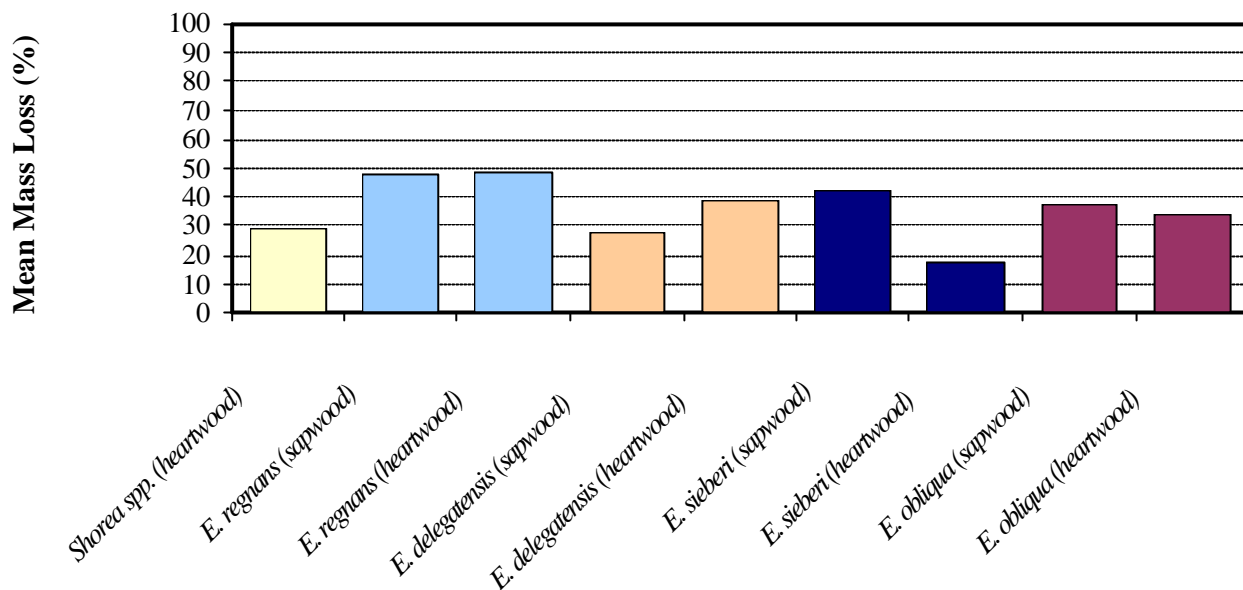
The treated test blocks were artificially weathered, and exposed to three species of decay fungi. One white rotting fungus (*P. tephropora*) and the brown rotting fungus (*Coniophora olivacea*) were able to substantially decay the solvent (white spirit) treated control test blocks (Figures 2.1 & 2.2). The second white rotting fungus, *Ganoderma cupreum*, was less active, but was still able to cause significant decay (Figure 2.3). Those timbers with in-ground heartwood of natural durability class 3 (*E. obliqua*, *E. sieberi*) had greater resistance in the decay trial than the class 4 timbers *E. regnans*, *E. delegatensis* and *Shorea* spp.

Figure 2.1: Mean percentage (%) mass losses caused by *P. tephropora* in solvent treated blocks.

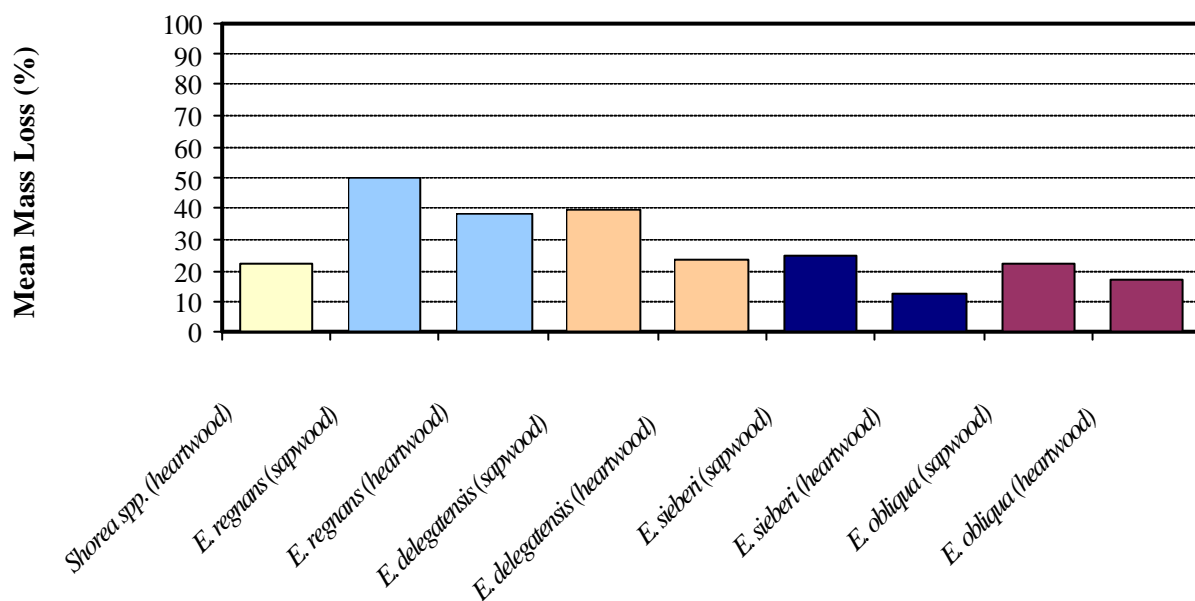
Figure 2.2: Mean percentage (%) mass losses caused by *C. olivacea* in solvent treated blocks.

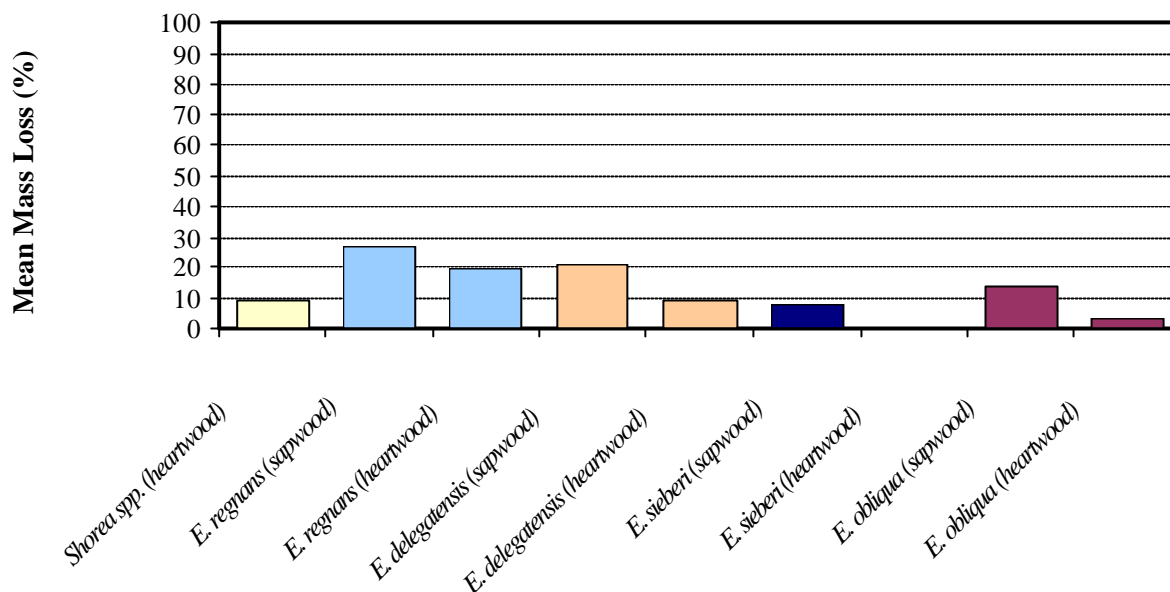
Figure 2.3: Mean percentage (%) mass losses caused by *G. cupreum* in solvent treated blocks.

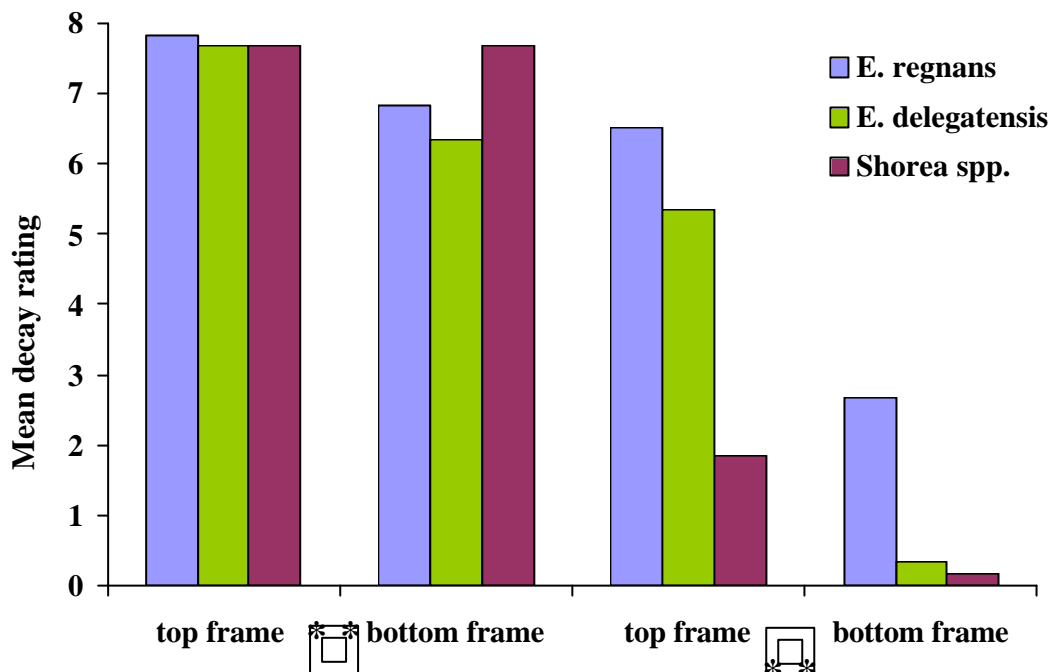
Decay was most severe in painted window frames constructed from *E. regnans* (mountain ash), *E. delegatensis* (alpine ash) and *Shorea* spp. It is accepted that the heartwood of these timbers is non durable<sup>17</sup>. Minor decay was also detected in frames made of untreated *E. obliqua* (messmate) and *E. sieberi* (silvertop ash), as was found in the soil-block bioassay, and is consistent with their higher in-ground natural durability rating of 3. The data in Table 4.1 show that the extent of decay was greatest in the bottom rebates. Furthermore, the decay was more severe in the windows that were suspended beneath another window frame (the lower row) (Figure 4.1). There was no decay in *T. plicata* (western red cedar) windows.

as water was able to bypass the paint layer at the joints and between the glass and timber beading (there was no putty or sealant). The paint appeared to have acted as a water trap. Accordingly, once wet, the painted timber required a much longer time to dry, accelerating decay.

Figure 4.1: Comparison of mean decay ratings in the upper and lower rebates of painted/untreated window frames made from *E. regnans*, *E. delegatensis* and *Shorea spp.* according to whether frames were suspended in the top or bottom row within the exposure bin.
